# MAURY HOME INSPECTIONS, LLC

## *Property Inspection Report*

**Inspection Site:** 3318 Rowland Place N.W. Washington, D.C. 20008

**Inspection Date:** 8/9/2018

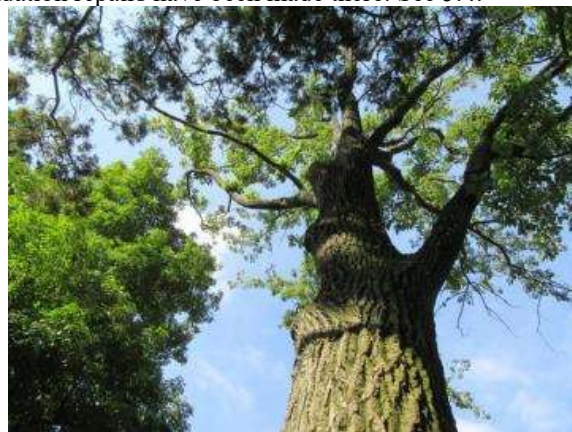
Trees are overhanging the roof. Damage is possible. Dead limbs were noted in the trees and should be cut out. Trim the plants away from the structure. Try to keep an air space between the building and shrubs. Vines should be cut back at least from the woodwork and gutters, preferably off all the masonry. Wooded site, expect extra leaf duty (gutters). Tree limbs are touching the garage, they should be cut back.

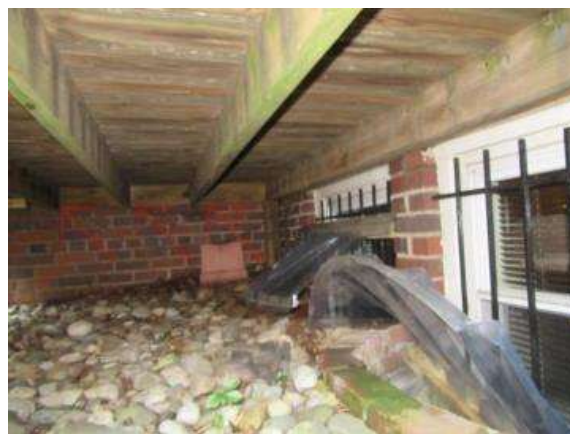
The deck is old and does not employ all the components and techniques used in modern deck construction.

**DECK STRUCTURE:** Missing Joist hangers. Joist hangers should be installed where they are missing.

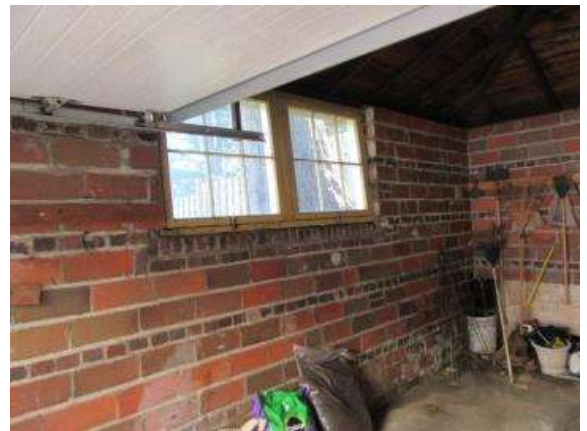
Further evaluation needed ideally by an engineer. The walls have racked and the building is not plumb and square. tree root pressure is suspected. The walls have structural damage. Differential settlement in the wall support has caused other crack distortions.

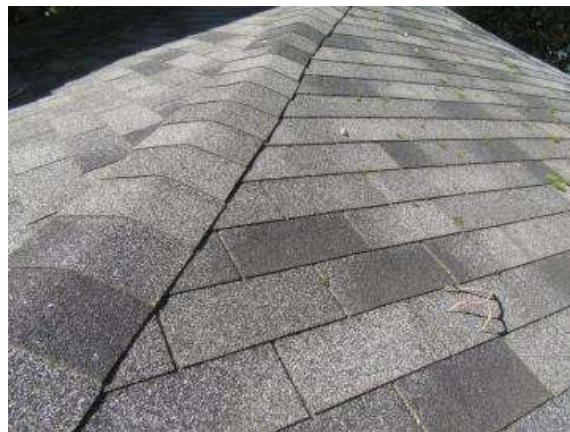
We recommend that you add gutters. No gutters on three sides. They are essential to preserving building stability and preventing water damage.

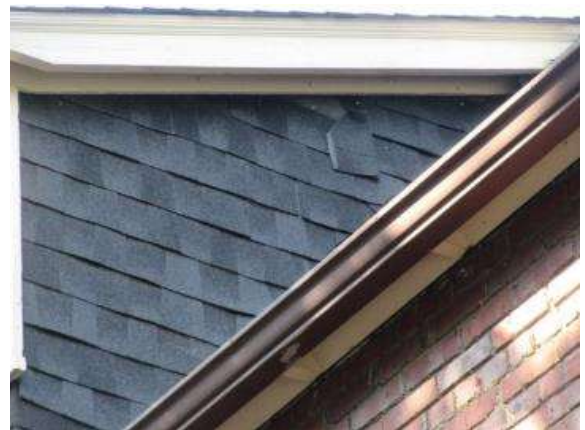
Remedial repair work needed to keep the roof serviceable. If this work is done the roof will be in satisfactory condition. Have a qualified roofer evaluate the roof and repair the items noted. Wind damaged shingles need repair. A lot of shingles are missing and or broken. Remedial repair work needed to keep the roof serviceable. If this work is done the roof will be in satisfactory condition. Shingles up the side dormers need repair. The Roofer may determine the shingle installation is poor and more shingles may be found loose. There is a moss and lichen growth on the roof. This only affects performance if you let it get out of control.

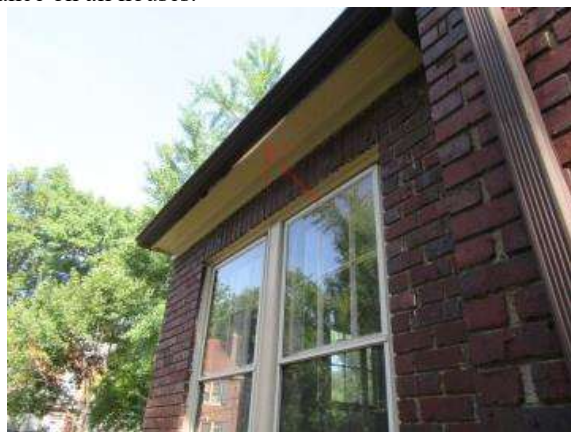
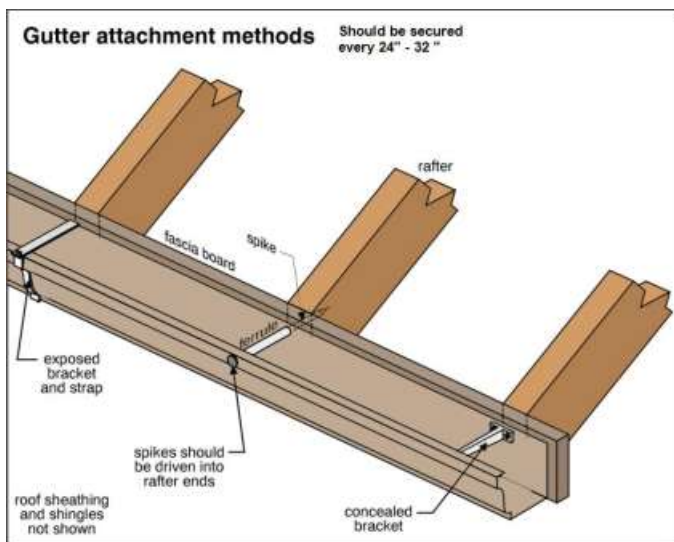
**CONDITION:** Many spouts go to under ground drains. The outlet points of the buried drain lines were not found. Run a hose through the drains on a dry day and find the outlets and make sure they are open. Flush out all the existing drains.

Loose guttering was observed out back that should be re-attached. Water will get behind it and it will overflow. The nails have pulled loose in places. Have them re-nailed and make sure you hit solid wood.

The house needs typical general repairs that you should consider routine maintenance in the future. Clean all the gutters, seal the joints, correct the sags and make everything flow to the downspouts, clean out the drains, and make sure all the discharge points flow safely away from the house. This is critical routine maintenance on all houses.

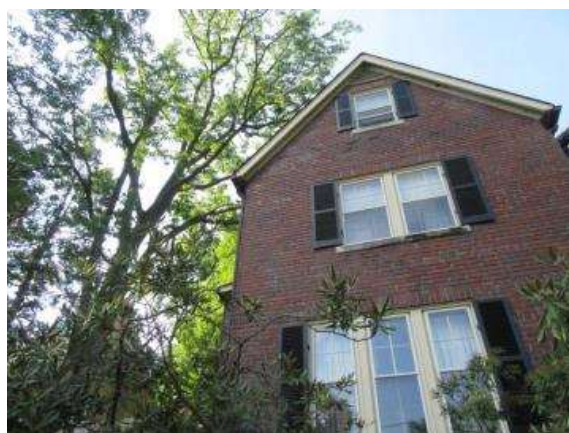
The house has a moderate volume of surface area to paint. The paint is flaking in the high exposure areas. The rakes and fascia need to be painted. Generally satisfactory. The paint is adequate for a while. Some wear was noted in the high exposure areas.

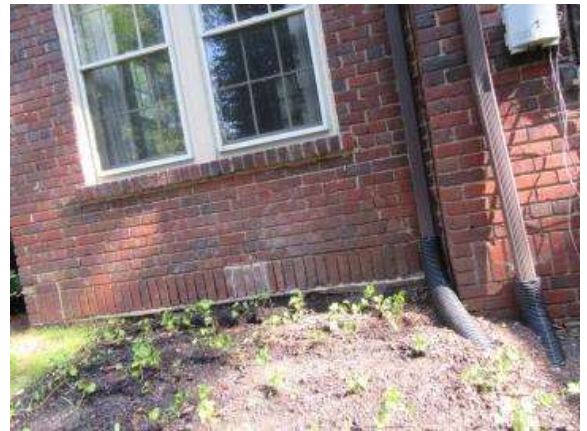
No major masonry problems were observed. All the mortar is sound and the masonry appears stable. The cracks in the masonry are not major but of course should be monitored. Have the cracks sealed by a qualified mason.

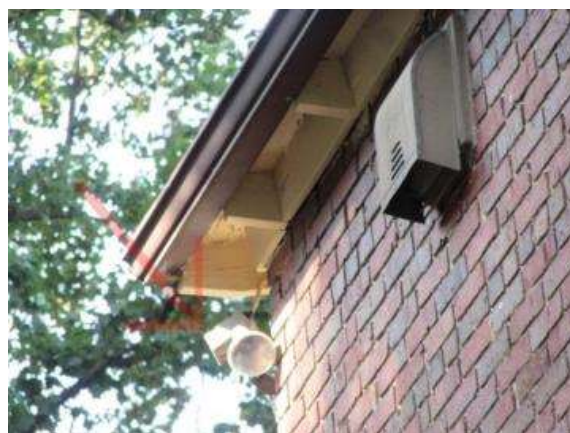
The telecom Vios / TV / cable / wiring is not trained neatly and professionally. Add some zip ties to keep wires secure, The spot light on the rear corner is loose.

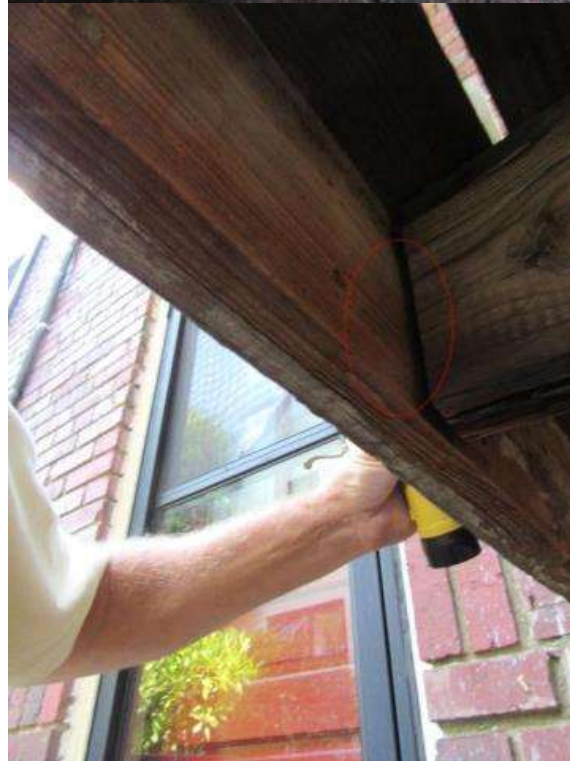
The joist structure should have metal hangers added to help keep the members secured together.

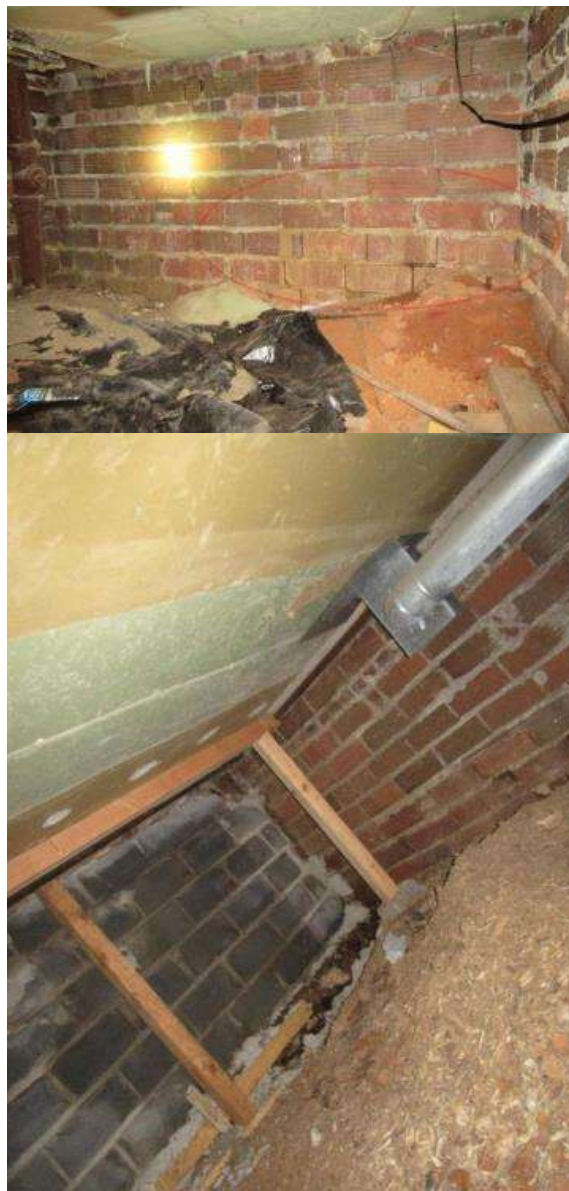
Satisfactory. No evidence of any major distress. Small differential settlement cracks were noted. These are common and are not considered structurally threatening..

Masonry wear should be "pointed up" Consult with a mason or handy man. The walls within the east side crawlspace need "pointing"

The rear wall of the west side crawlspace was recently rebuilt. Satisfactory. No evidence of any major distress.

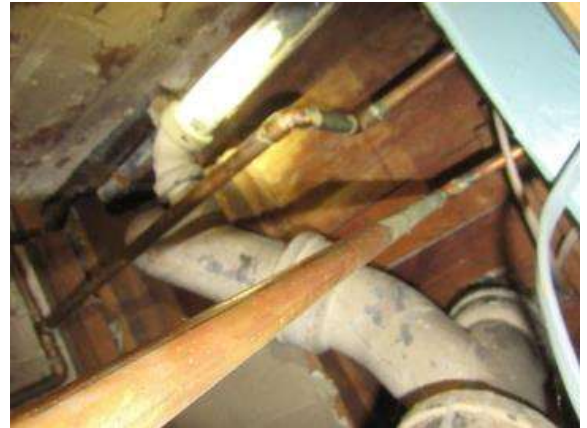
Some substantial and structurally significant termite activity was visible in numerous areas. The main activity was up under the powder bathroom. Get a qualified carpenter to further investigate the area.

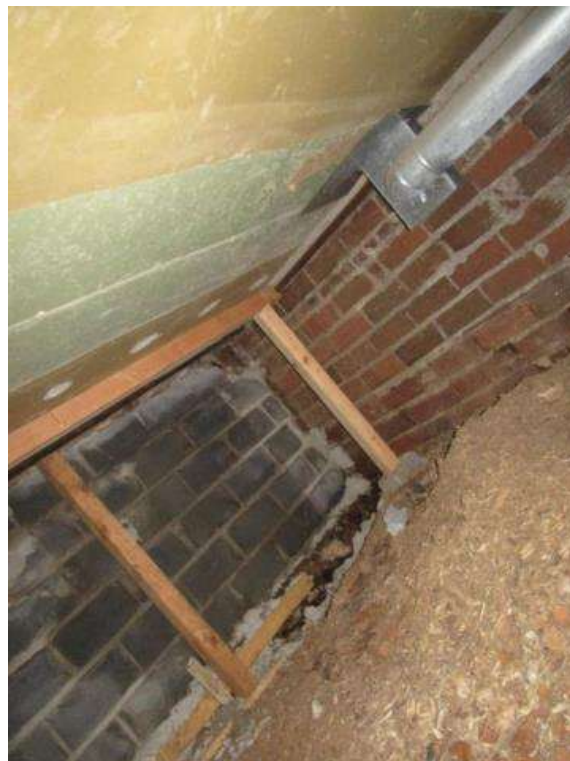
The rear corner in the crawlspaces is stained. Efflorescence was noted. This is caused when water penetrates through the masonry and then dries up leaving behind a mineral deposit.

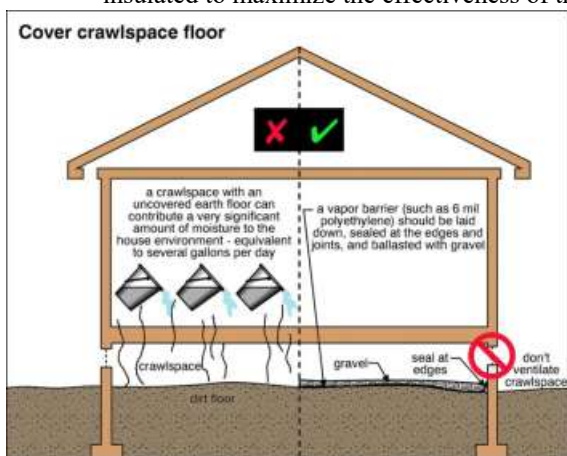
There is a lot of debris in the crawlspace that needs to be cleaned out. Excessive wood mulch in the west side needs removal. Encapsulation of the crawlspaces with a continuous and sealed vapor barrier is recommended. With this technique all ventilation to the outside is closed off. All water is managed and kept out of the crawlspace. The air temperature and humidity are kept constant which minimizes the conditions conducive to mold growth. The perimeter walls should be insulated to maximize the effectiveness of this technique.

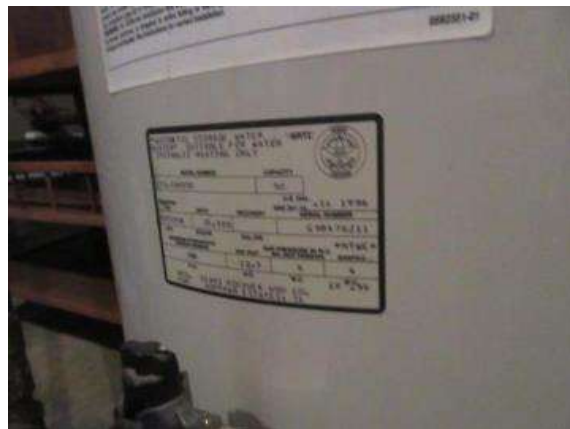
Satisfactory. The unit operated normally. The unit is near the end of its useful life. There is no safe pan under the water heater to protect the finishes if you have a leak. That is not good practice. Monitor, The unit lacks the expansion tank as per the latest code.

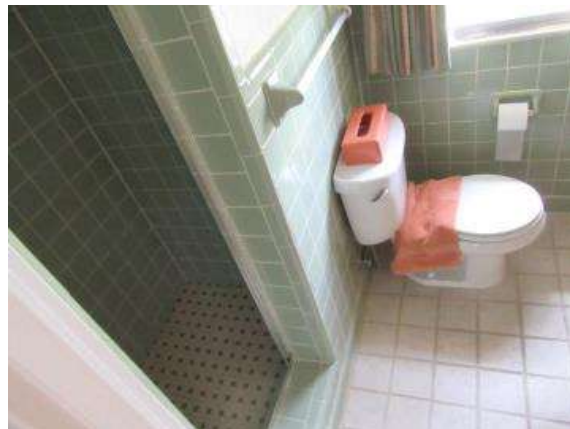
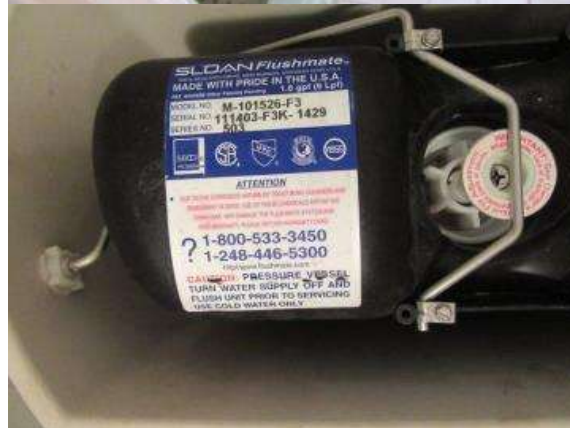
All four toilets are this SLOANE type.

This recall is for Series 503 Flushmate III Pressure Assist flushing systems installed inside toilet tanks that were manufactured from March 2008 through June 2009. The units are rectangular, black, two-piece vessels made of injection molded plastic. Previously recalled systems were manufactured from October 1997 through February 2008. Recalled units have a date code/serial number that is 16 characters long and is located on the label on the top of the Flushmate III. The first six numerals of the serial number are the date code. The date code range for units included in this recall in MMDDYY format is 030108 (March 1, 2008) through 063009 (June 30, 2009). The date code range for previously recalled systems in MMDDYY format was 101497 (October 14, 1997) through 022908 (February 29, 2008). Units included in this recall were sold individually and installed in toilets manufactured by American Standard, Crane, Ecotech, Eljer, Gerber, Kohler, Mancosa, Mansfield, Orion, St. Thomas, Universal Rundle, Vitra, Vitromex and Western Pottery.

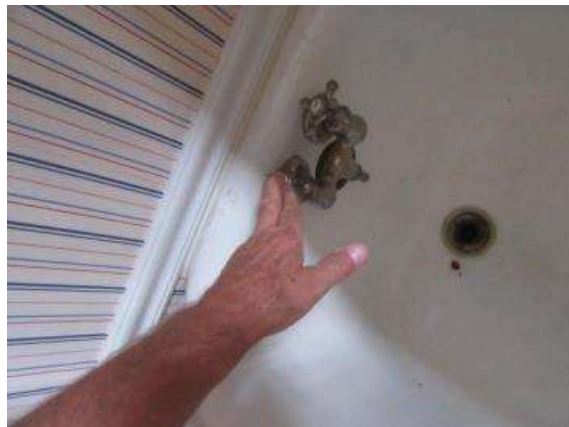
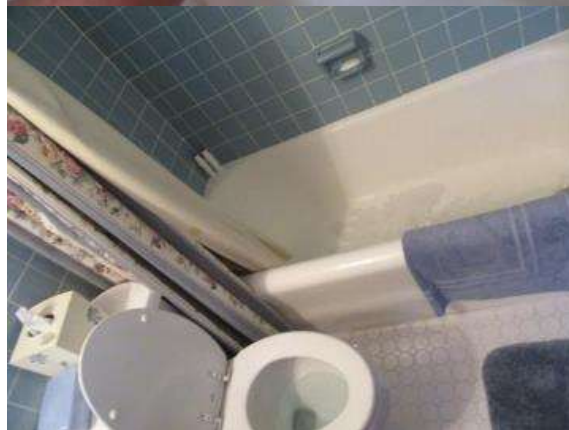
The tub finish has worn, needs re-glazing.

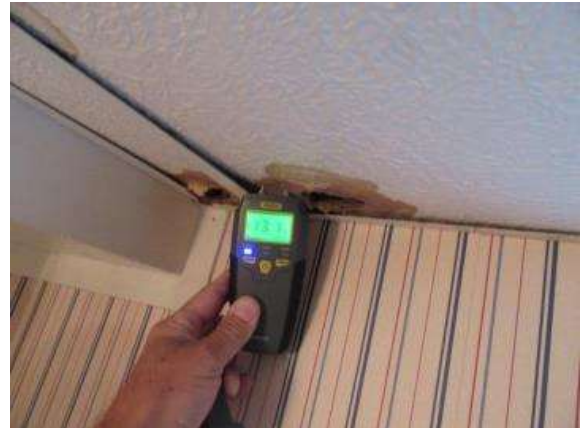
Below the powder room. Stains were tested with a moisture meter and found levels elevated. Further evaluation needed. Leak evidence observed.

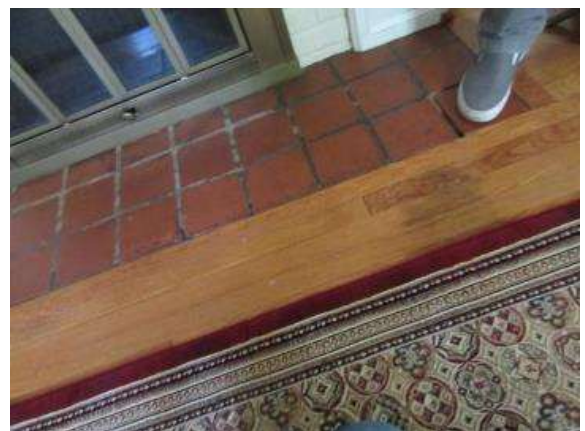
Some "shadowing" from UV light and area rugs, Further evaluation needed after the furnishing have been removed. The floors are stained.

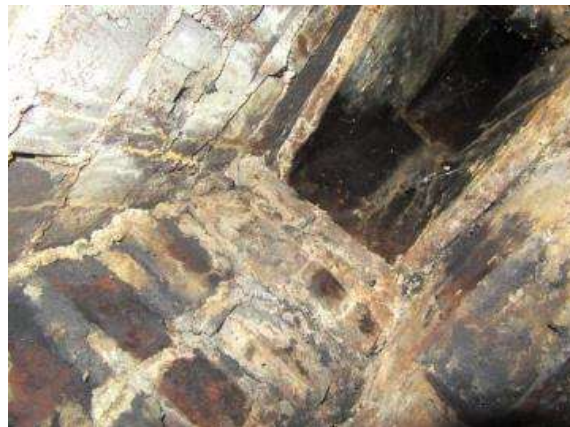
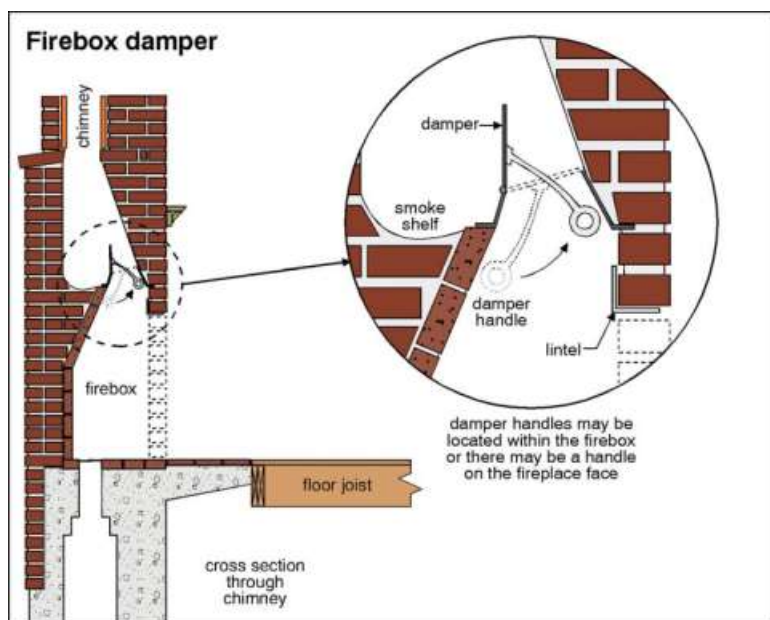
**HEARTH, MANTLE, & SURROUND:** The cracks at the hearth need repair.
