MAURY HOME INSPECTIONS

Property Inspection Report

Inspection Site: 1208 D Street SE Washington, DC 20003

Inspection Date: 10/7/2013

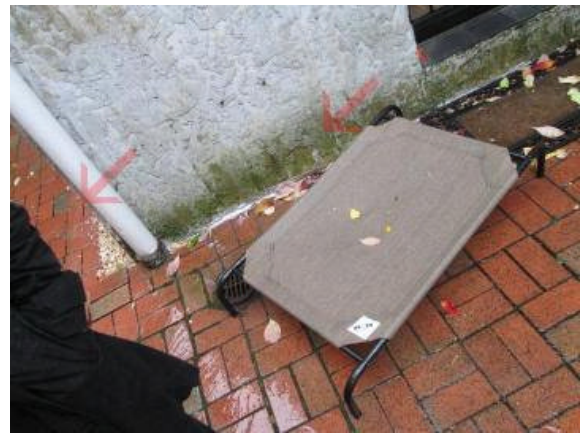
An underground drain system is integrated into the surface water control plan. Good maintenance is very important. The drain(s) are not in the lowest point of the walks and patios. The side yard patio doesn't have good run off away from the house.

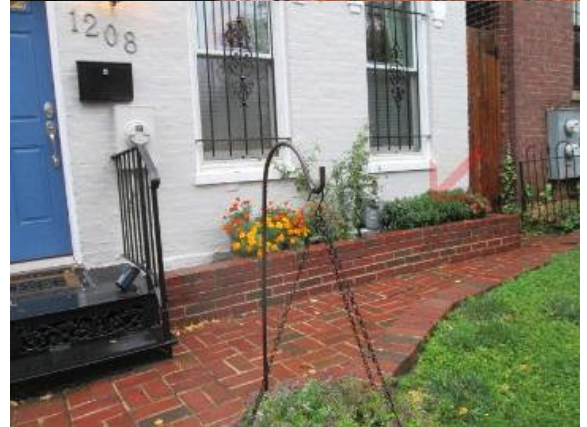
The current run off plan does not control surface water correctly. The site plan allows the potential for developing good run off but work is needed to develop it.

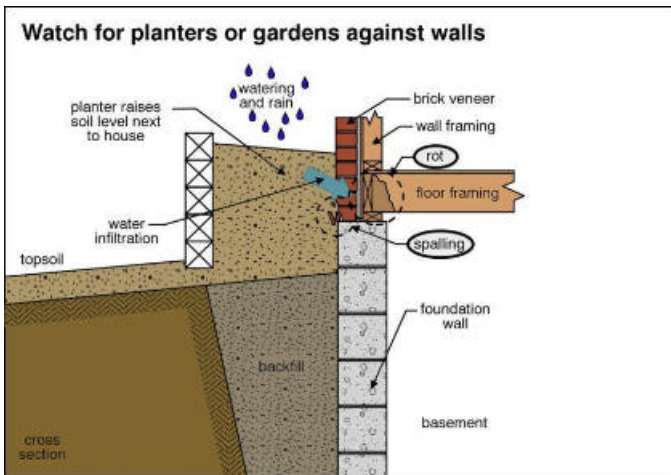
The grade is too high on the brick at the front garden planter. This exposes the wood interior to moisture and potential decay.

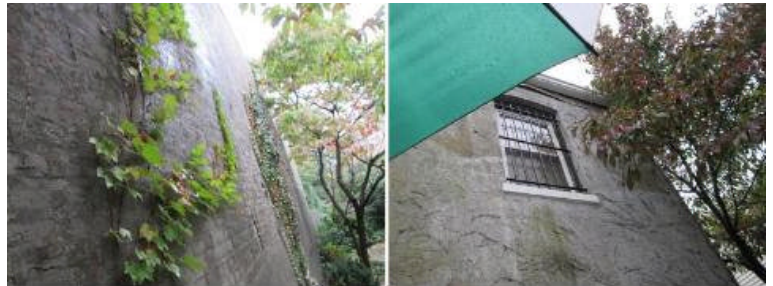
No apparent direct effects on the structure. Tree limbs are touching the house, they should be cut back. Vines should be cut back at least from the woodwork and gutters, preferably off all the masonry.

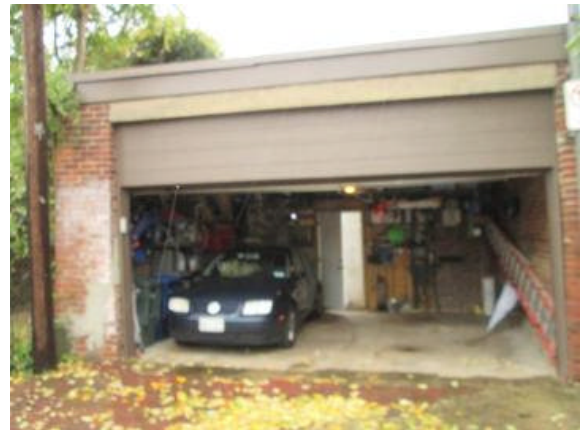
Substantial cracking has occurred at the apron of the garage. Portions missing. Still functional but substantially deteriorated.

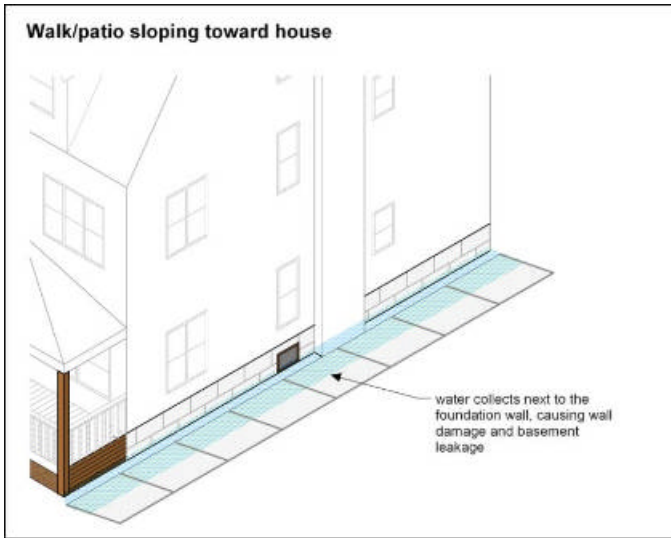
WATER RUN OFF: At present they do not provide a clear and definitive run off away from the building. Water may collect against the house during wet conditions. (See the basement section for visible signs of water problems)

Tree roots have disrupted the walk. This could be a potential trip hazard.

RAILING OBSERVATIONS: There is no railing. Typically if you have three steps or 24" height you install a railing.

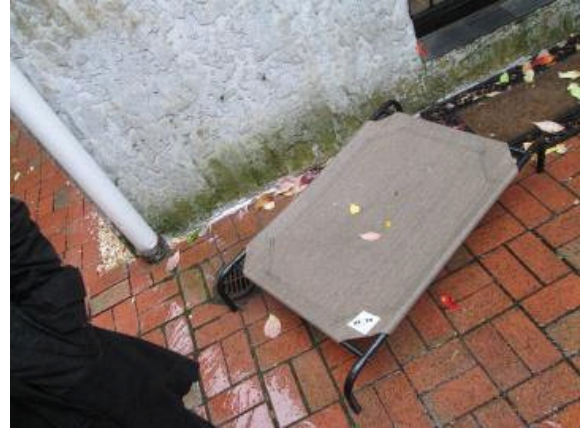
The patios are an integral part of the site run off plan. At present the patio is diverting water against the building. This is a common cause of many interior and exterior water problems.

AREA DRAINS: The area drain is not in the lowest point of the run off. It is not draining the water on the patio. recent patch work at the patio / house corner may indicate some water problems (stucco decay)

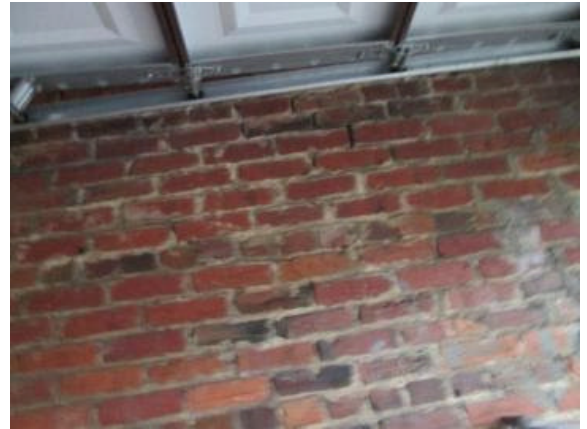
The walls are bowed, The walls have racked and the building is not plumb and square. Monitor.

The inside of the brick walls need mortar "point up" Not a priority but should be done sometime.

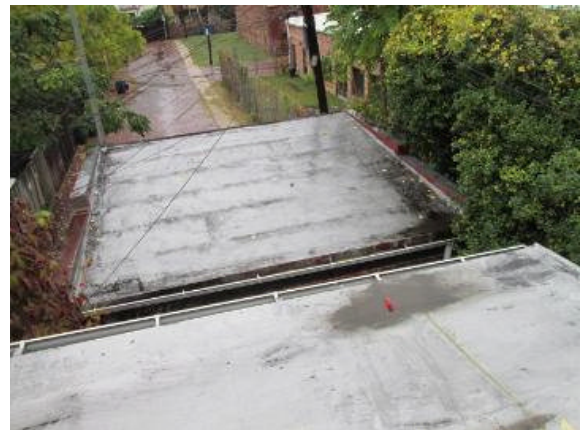
The roof needs a new coat of alumination. Usually you spot repair the roof at the same time. Water is ponding on the roof which accelerates wear and increases the leak potential.

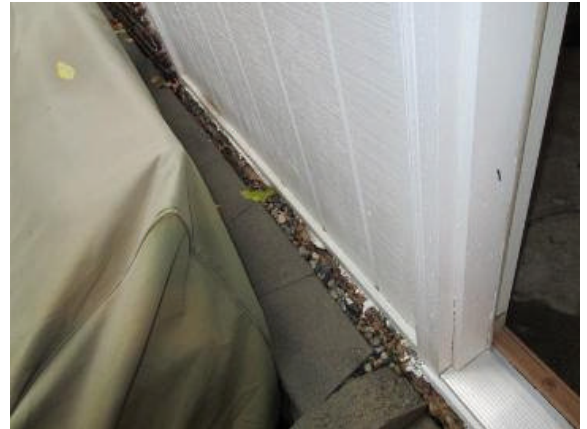
Water is getting in through at the foundation wall at the wood section.

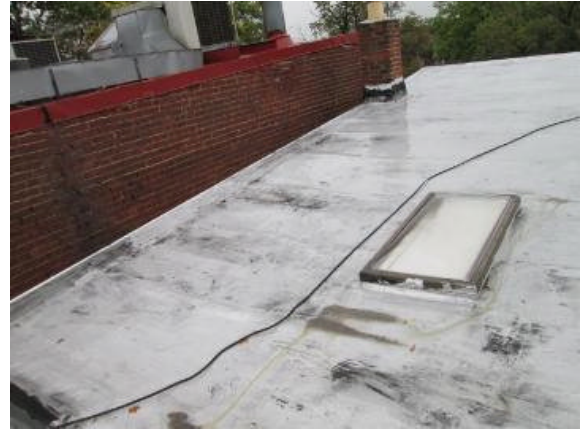
Projected Life Expectancy: The roof should last at least 10-15 more years if correctly maintained. There are Multiple layers. There is not supposed to be more than two because of weight considerations. You need a roofer who is qualified to work on low slope roofs to fix the problems noted. The roof needs a newer coat of aluminum roof coat. Patch any open seams, holes or cracks before applying the aluminatation. This is not an eminent need, I say in the next two years you should have the roof painted. Typical commercial roofing last about 20 to 25 years if correctly maintained.

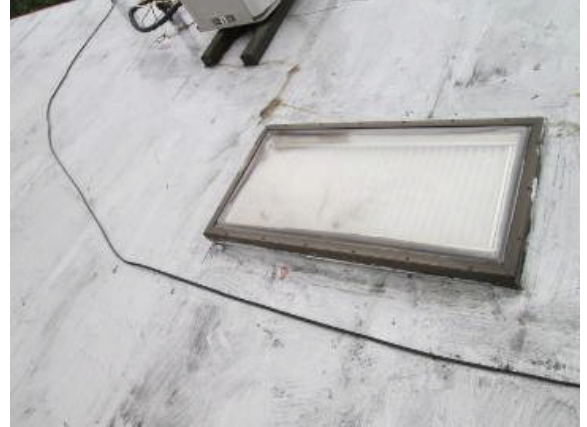
CONDITION: Satisfactory, there are no visible defects in the glass, or flashings. The curb of the skylight is too low to effectively prevent leaks especially during snow events. The plexiglas is crazed from age. The crazing at first affects the aesthetics and then starts leaking. No active leaks seen today.

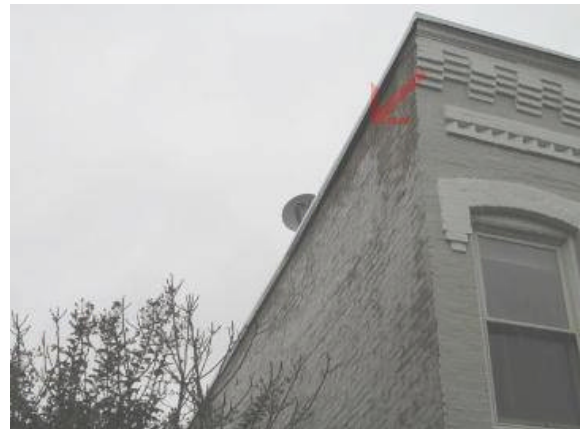
Birds and/or squirrels are getting into the cornice line down the west side. There are gaps between the frieze and the walls that need to be sealed up.

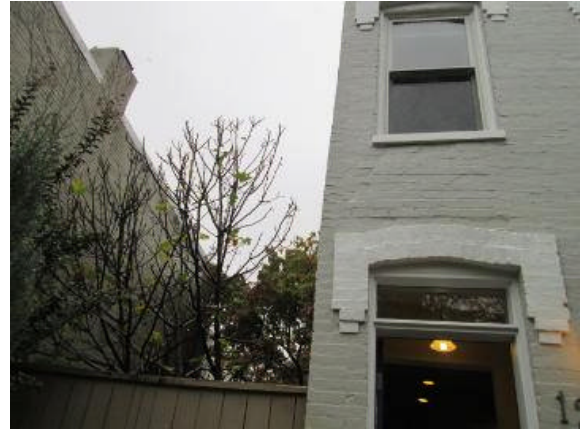
There is some structural distortion but it was not considered threatening or abnormal.

Masonry conditions observed: The walls do have some bows from the outward force exerted by the arches. The arches have distorted but need no immediate repair. The slope of the window sills is not the prescribed 1/8th inch plus. Water may be able to get in.

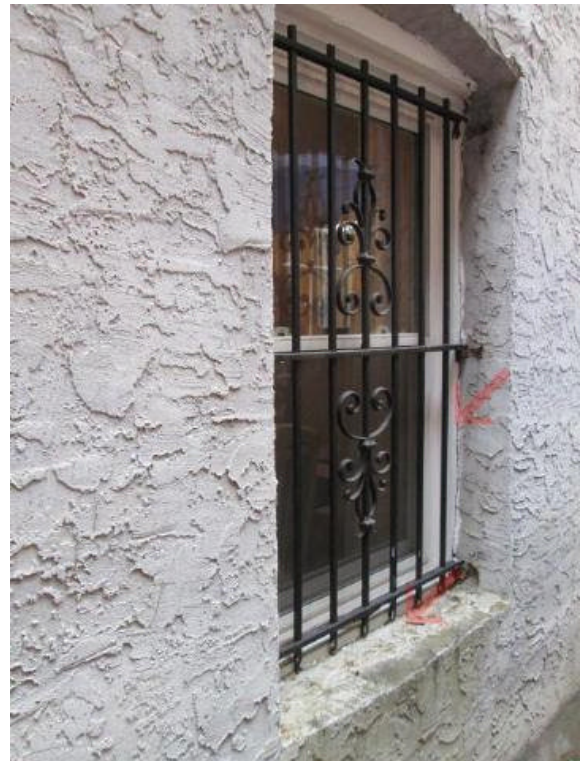
The house has a moderate volume of surface area to paint. Generally satisfactory. The paint is adequate for a while. Some wear was noted in the high exposure areas. The windows need to be caulked around the perimeters.

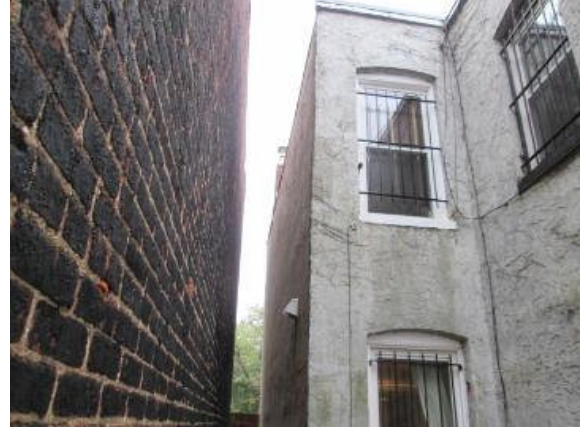
Satisfactory. Security bars do not allow occupants out of a building during an emergency. (FIRE) Somewhat frowned upon by the fire department. The 2nd floor window bars should be removed.

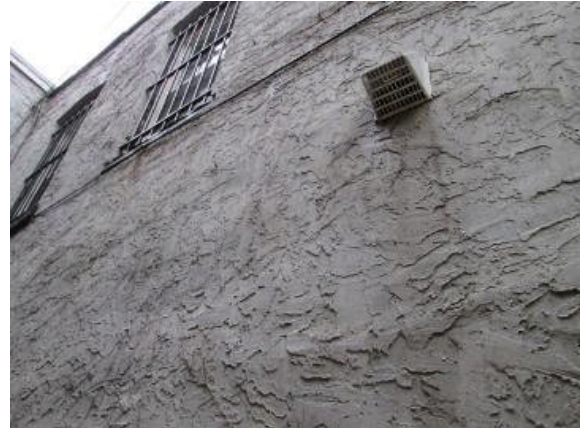
See dryer comments. No air is found at the louver for the dryer. The vent covers outside need caulking.

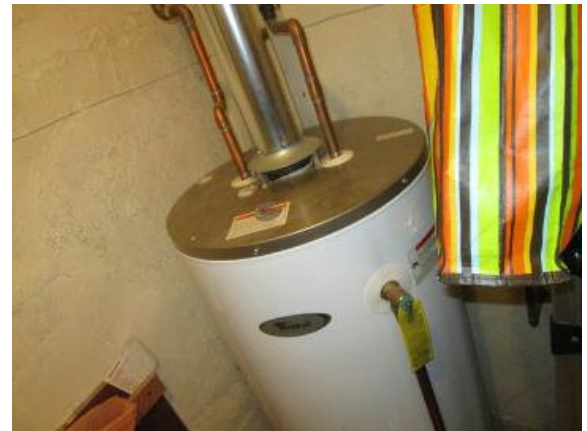
The unit operated normally. There is no safe pan under the water heater to protect the finishes if you have a leak. That is not good practice.

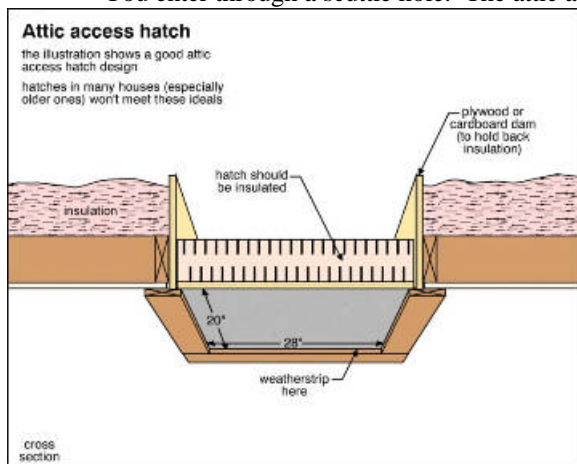
You enter through a scuttle hole. The attic access is not insulated. They should be insulated to prevent heat loss.

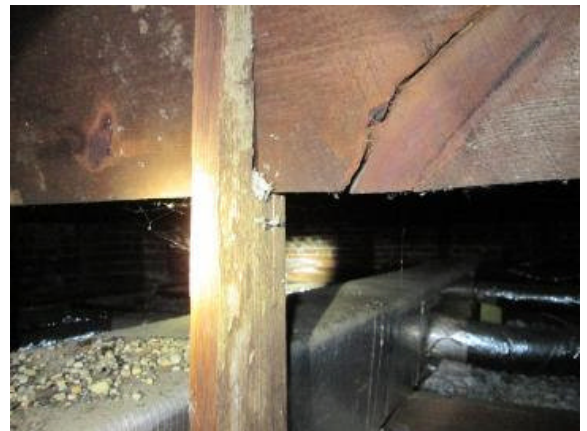
Upon further review of the photos Another cracked beam was found. The rear beam was already repaired. Another near the scuttle needs re-enforcement. Typically a "sistered" repair will help stabilize the beam . Consult with a carpenter

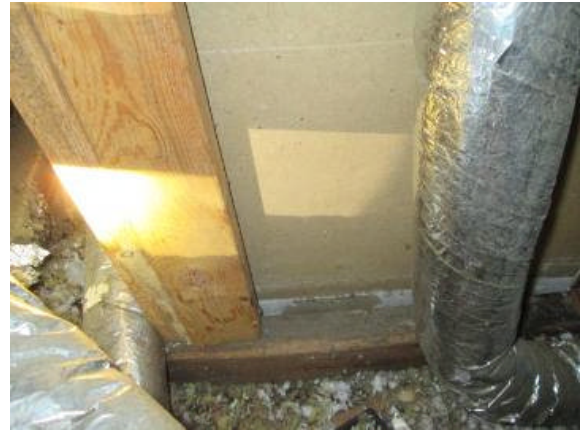
TYPE: Blown/poured. Fiberglass. **THICKNESS:** 4-6". There are some bare spots over the center office area.

Marginal. Not commensurate with modern standards. We recommend that you add more insulation. Caution If Adding Insulation. Don't block vents or cover lights that are not designed to be covered. Maintain clearances around furnace and water heater vents. Have it done professionally.

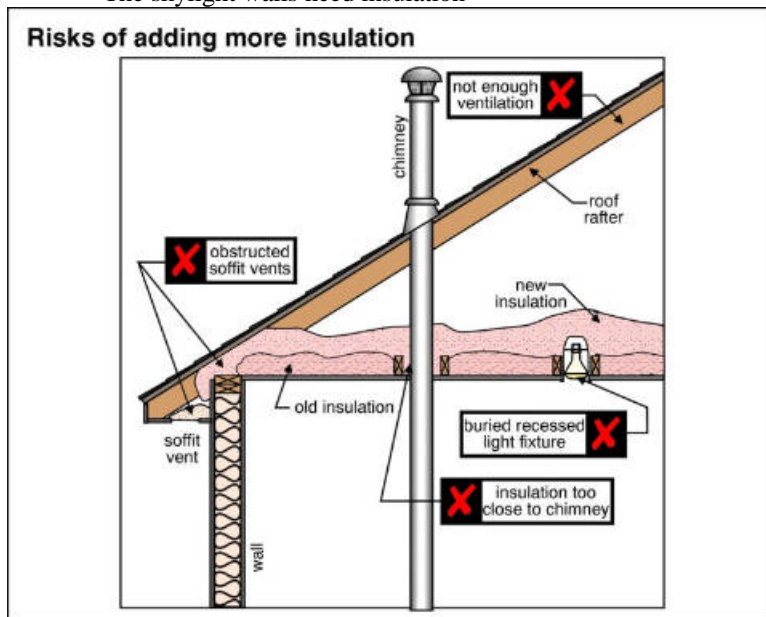
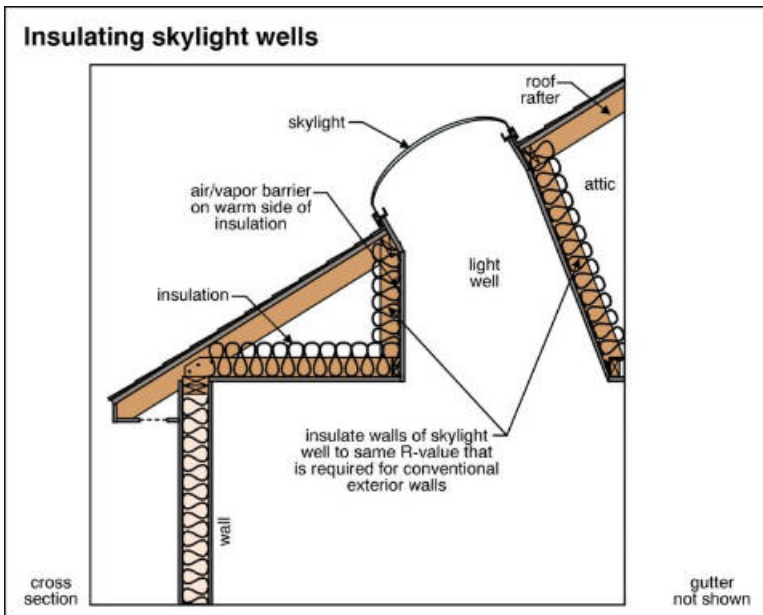
The skylight walls need insulation

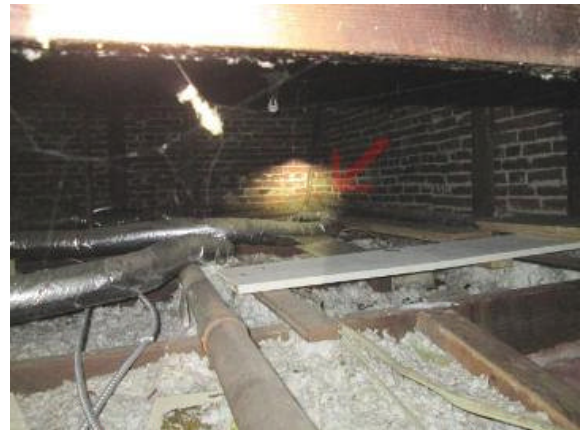
Birds have been getting in.

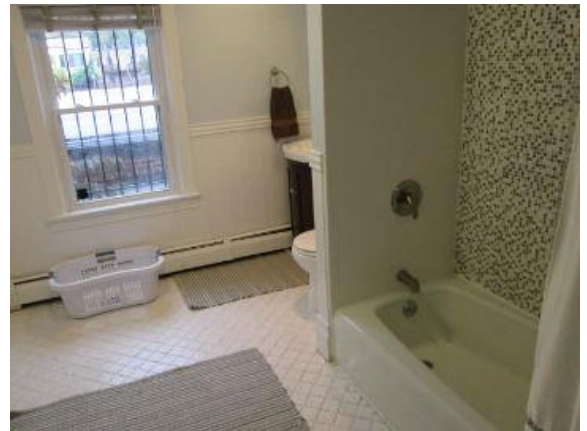
You need caulk around the tub fixtures.
