# MAURY HOME INSPECTIONS, LLC

## *Property Inspection Report*

**Inspection Site:** 3318 Rowland Place N.W. Washington, D.C. 20008

**Inspection Date:** 8/9/2018

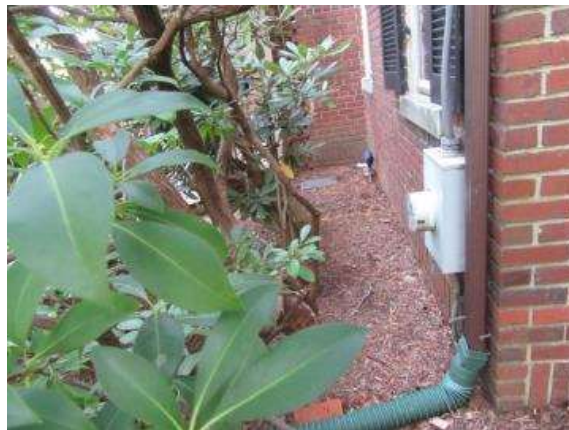
The grades are generally satisfactory but there are some low areas. Ideally you should try to develop ground slope directly around the house of 1 inch per foot for a distance of 6 feet with a clear continuous path for the water from there on. The ground does not slope away at one of the window wells. It is recommended that you hire a qualified landscaper to correct any low areas or cavities found so that surface water runs away from the house.

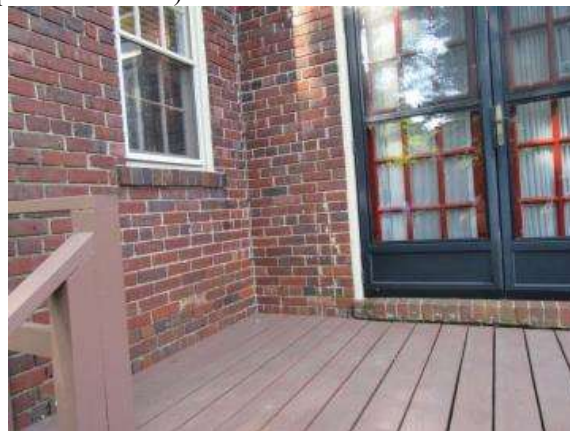
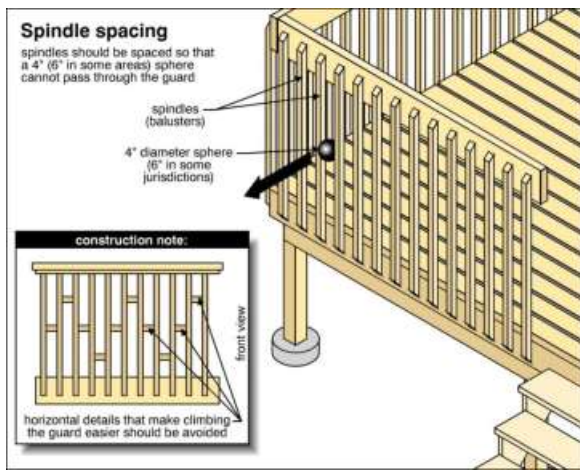
**DECK STRUCTURE:** Missing Joist hangers. Joist hangers should be installed where they are missing.

**RAILING OBSERVATIONS:** The railing is not child proof. (Open spaces exceed 4 ").

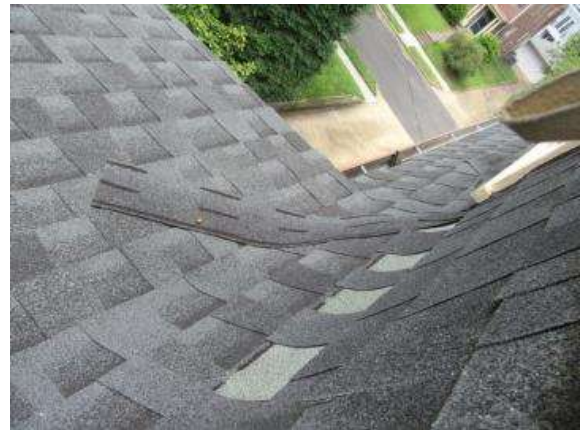
Remedial repair work needed to keep the roof serviceable. If this work is done the roof will be in satisfactory condition. Have a qualified roofer evaluate the roof and repair the items noted. Wind damaged shingles need repair. A lot of shingles are missing and or broken. Remedial repair work needed to keep the roof serviceable. If this work is done the roof will be in satisfactory condition. Shingles up the side dormers need repair. The Roofer may determine the shingle installation is poor and more shingles may be found loose. There is a moss and lichen growth on the roof. This only affects performance if you let it get out of control.

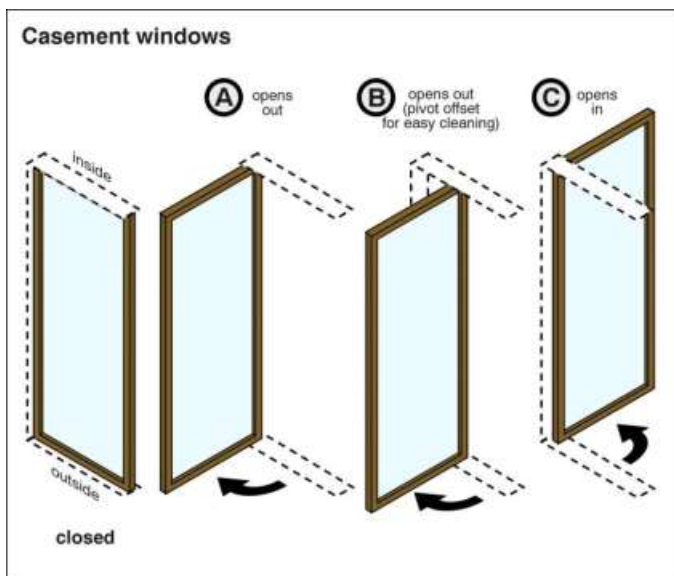
Some amount of restoration/repair is needed. Many of the windows are stuck. Some windows are hard to operate or painted closed. The house still has single glazed wood framed windows. These are poor insulators and the mechanics are problematic. You should consider replacement. Several sashes have damaged or broken sash cords, ropes, or balances.

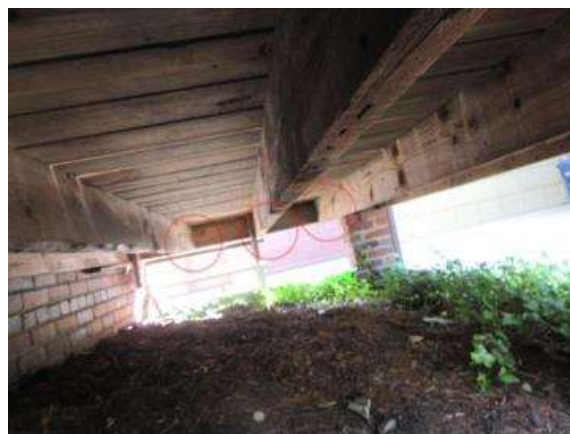
The joist structure should have metal hangers added to help keep the members secured together.

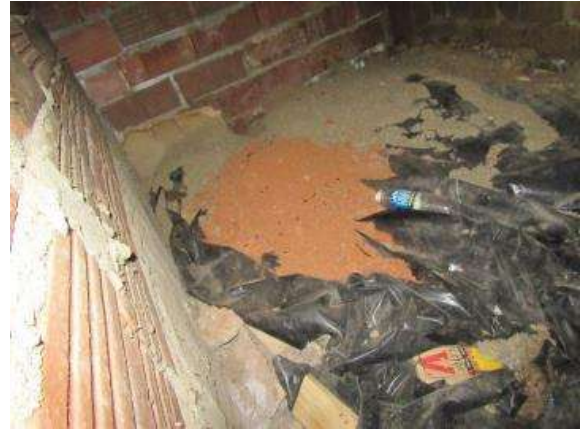
**VAPOR BARRIER:** It doesn't cover all of the ground. Improve it so that it does.

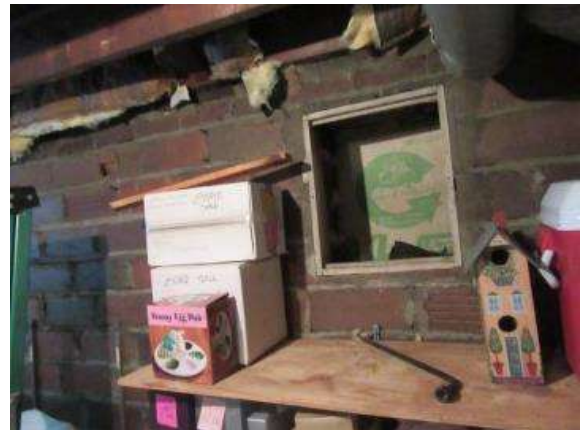
**METHOD OF INSPECTION:** Viewed from the door only. The hatch doors need improvement. They should be louvered.

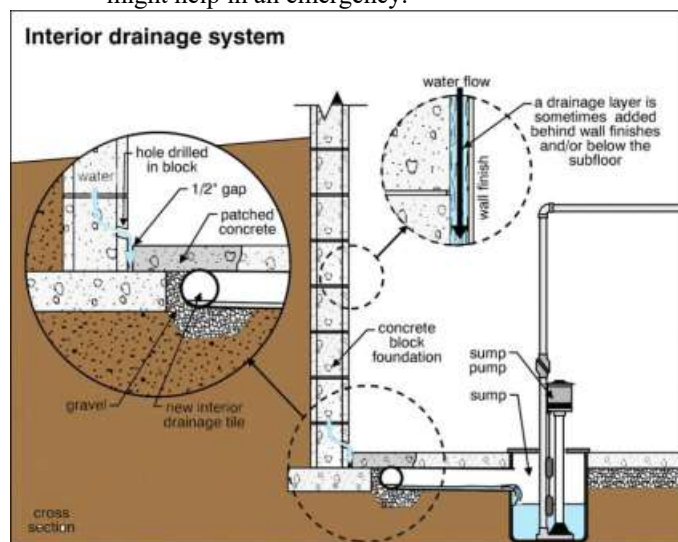
**SUMP PUMP OPERATION:** The pump appears to be working normally.

**BATTERY BACK UP:** You may want to add a battery back up pump. Even though they are not completely reliable it might help in an emergency.

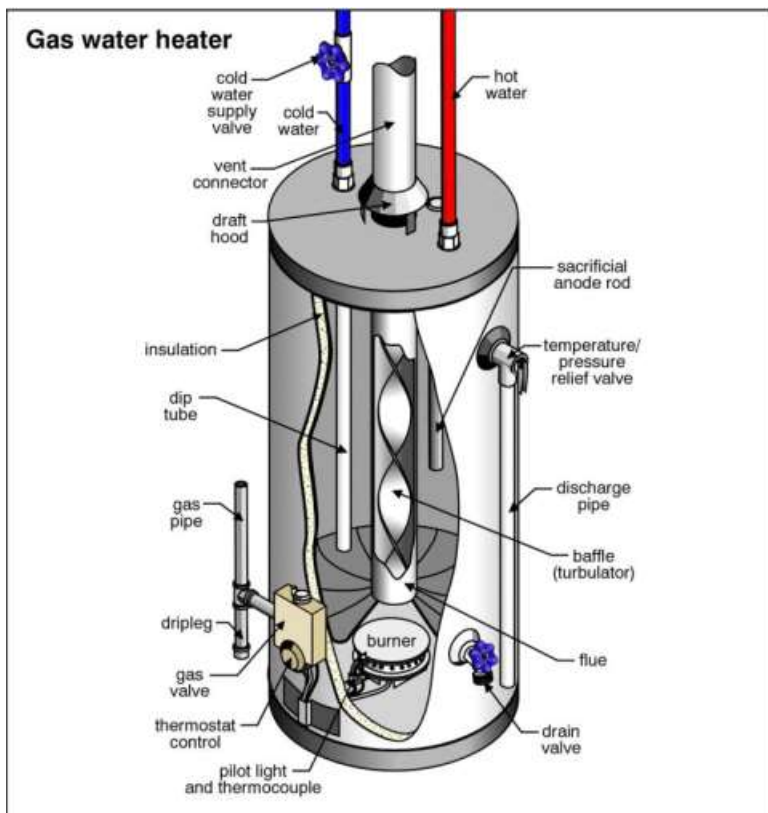
Satisfactory. The unit operated normally. The unit is near the end of its useful life. There is no safe pan under the water heater to protect the finishes if you have a leak. That is not good practice. Monitor, The unit lacks the expansion tank as per the latest code.

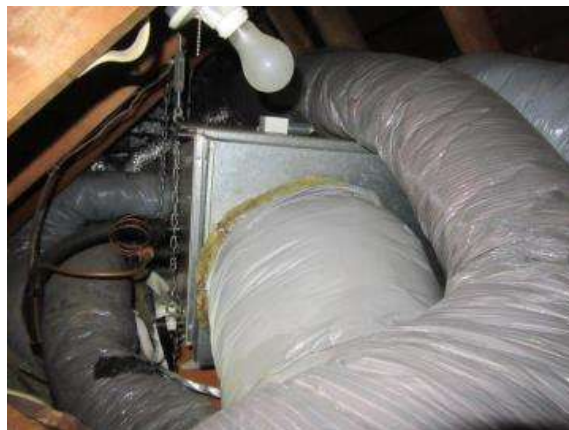
None. Based on the tests and observations made, all the components, functions, and conditions listed above were found to be satisfactory. Access to the attic unit is very difficult.

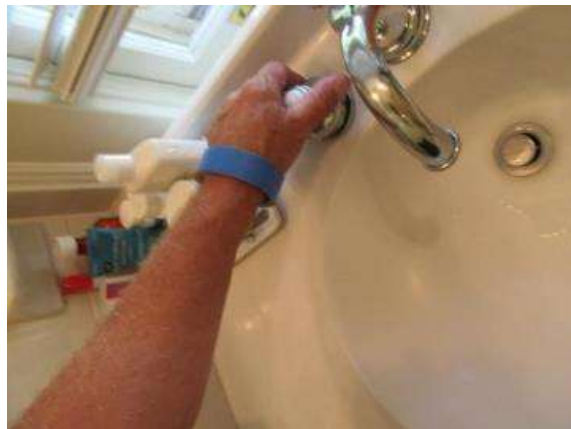
**FAUCET:** The faucets have been over tightened and are hard to turn. This is usually done to try and stop dripping instead of replacing the valve stems.
